Surface deformation produced by the 1999 Chi-Chi (Taiwan) earthquake and interactions with built structures

U. S. Geological Survey
National Earthquake Hazards
Reduction Program
Award Number 01-HQ-GR-0122

William Lettis & Associates, Inc.
1777 Botelho Dr., Suite 262,
Walnut Creek, CA 94596

December 2003

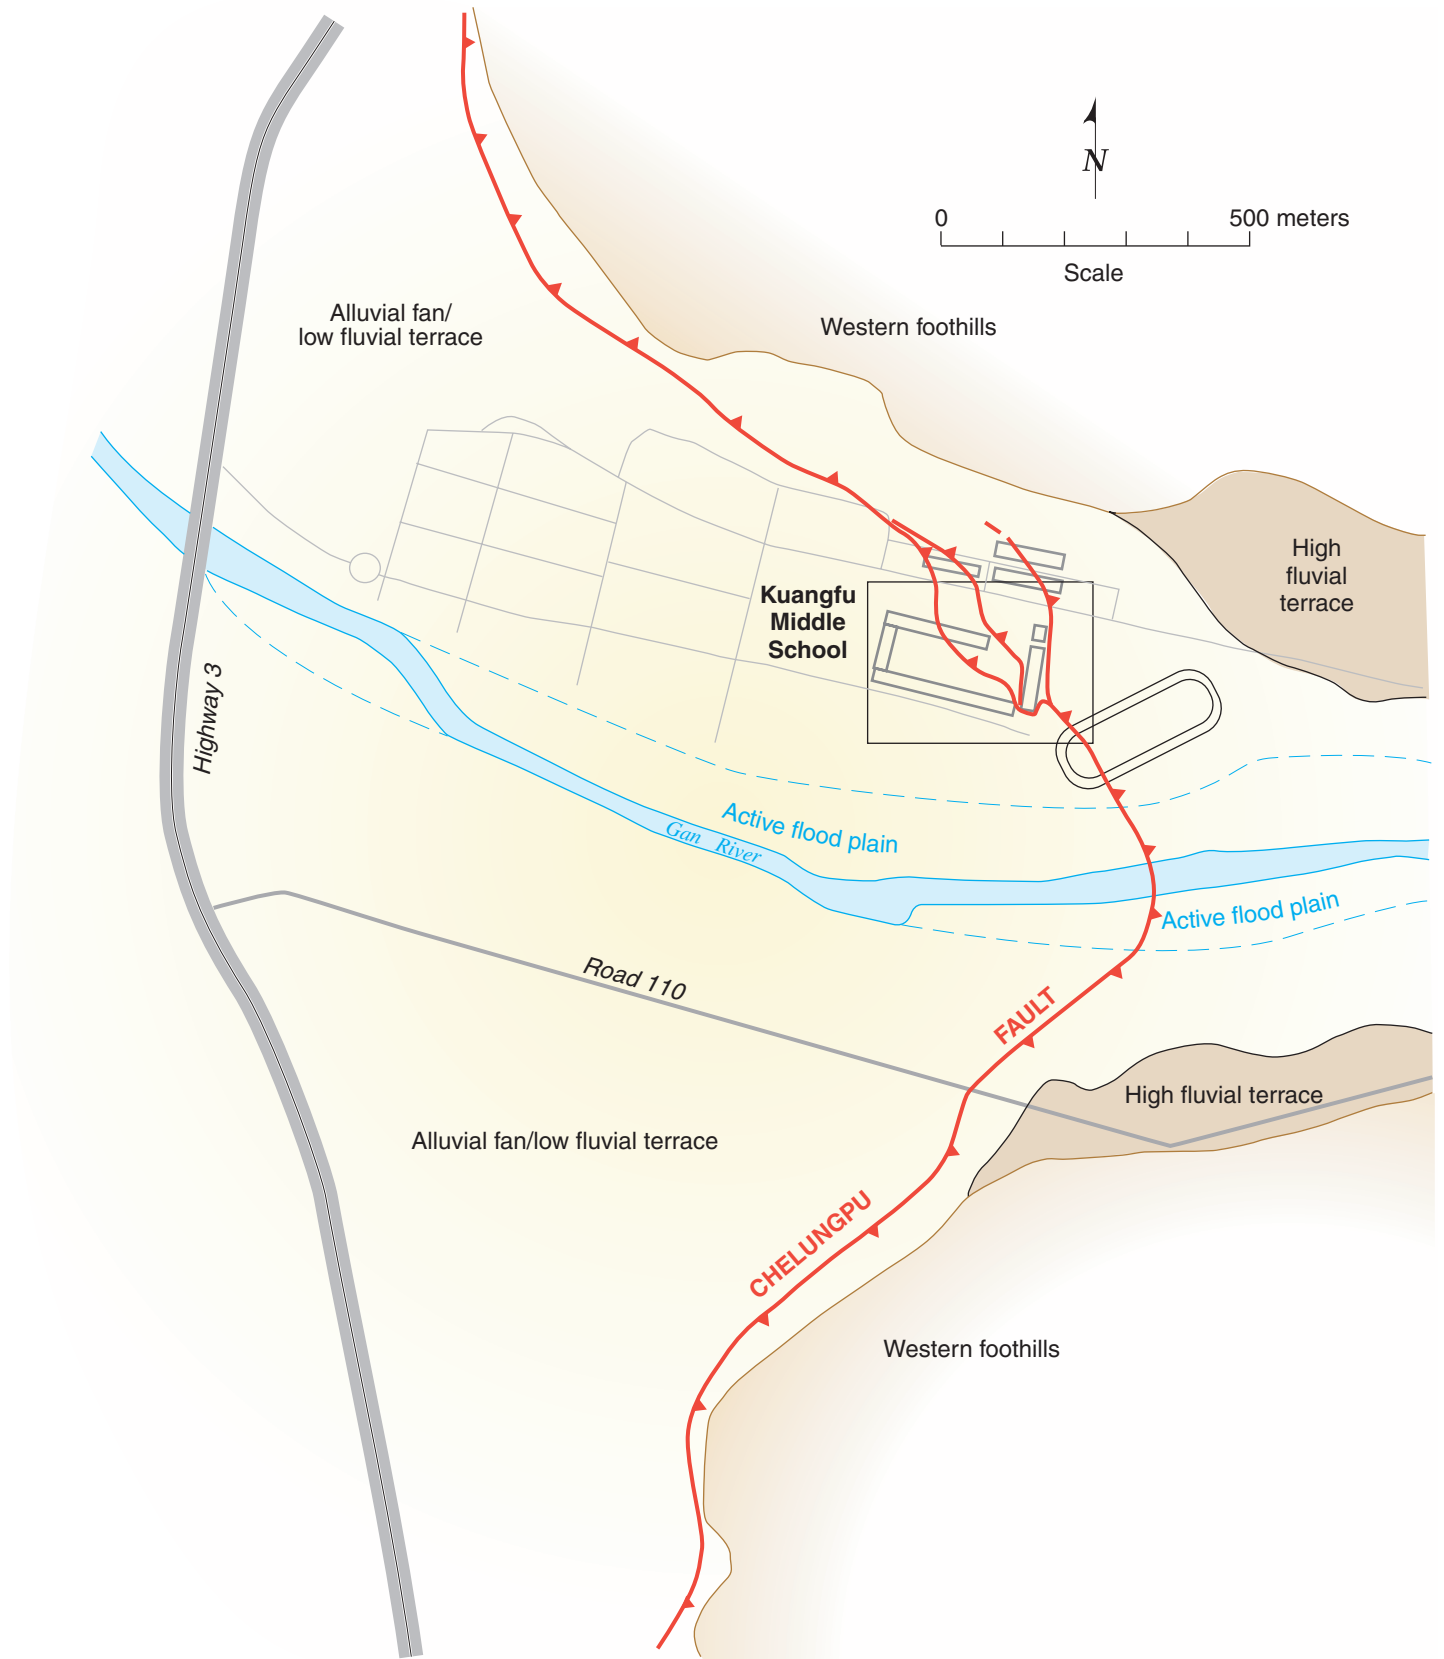
KuangFu Middle School is along the central part of the Chelungpu fault about 4 km southeast of central WuFeng (Figure 1). The school is on a 4-m-high late Holocene fluvial terrace flanking the northern margin of the Gan Hsi (River) (Figure 4). The coarse gravel terrace deposits rest upon shale of the Pliocene Chinshui Formation, are about 5 m thick on the hanging wall and more than 12 m thick on the footwall. The Chelungpu fault scarp strikes northwesterly through the school campus, and was unmodified at the time of our surveying in September 2001. Because the school rests on a very young stream terrace, the site contains geomorphic evidence of only the 1999 rupture. Within the vicinity of the school, the 1999 Chelungpu fault rupture is predominantly a single fault scarp across the Gan Hsi valley, except for the presence of three localized strands within the Kuangfu Middle School site (Figure 4).

Figure 4. Generalized geologic map of the Chelungpu fault in the vicinity of Kuangfu Middle School, south of Wu Feng. The trace of the 1999 surface rupture modified from mapping by the Taiwan Central Geological Survey mapping.

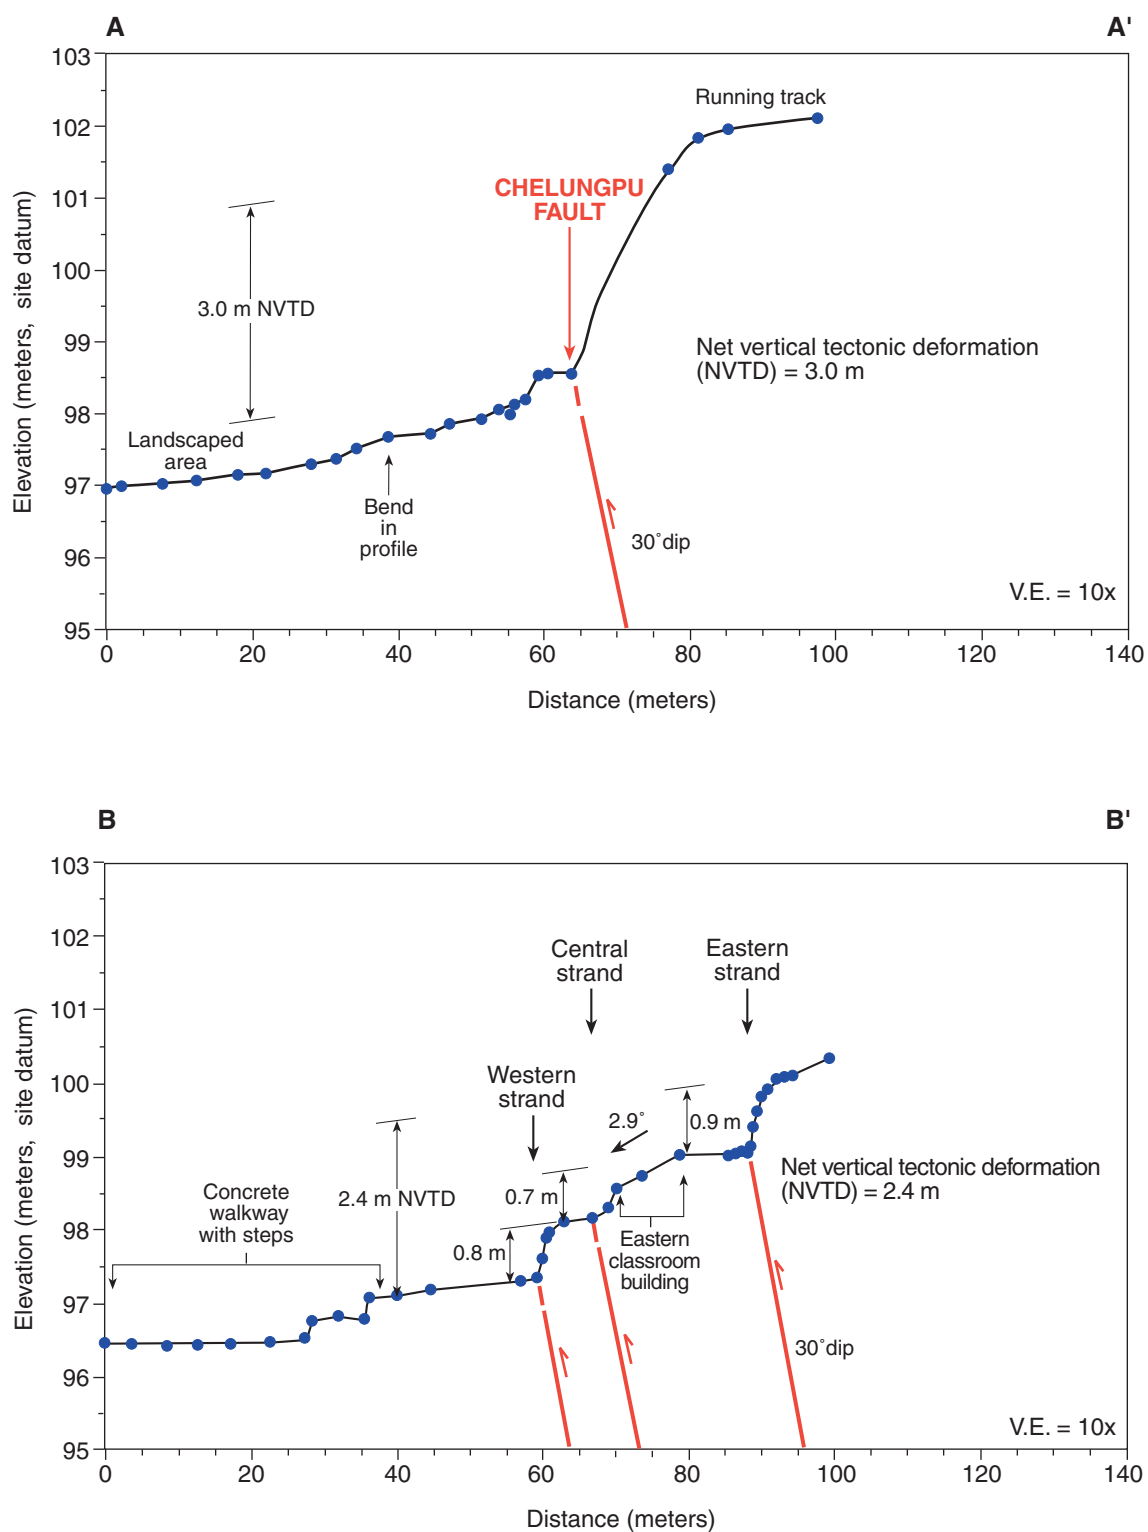
Figure 7. Topographic profiles AA' and BB', Kuangfu Middle School. Fault dip of 30°E is assumed. See Figure 6 for profile locations.

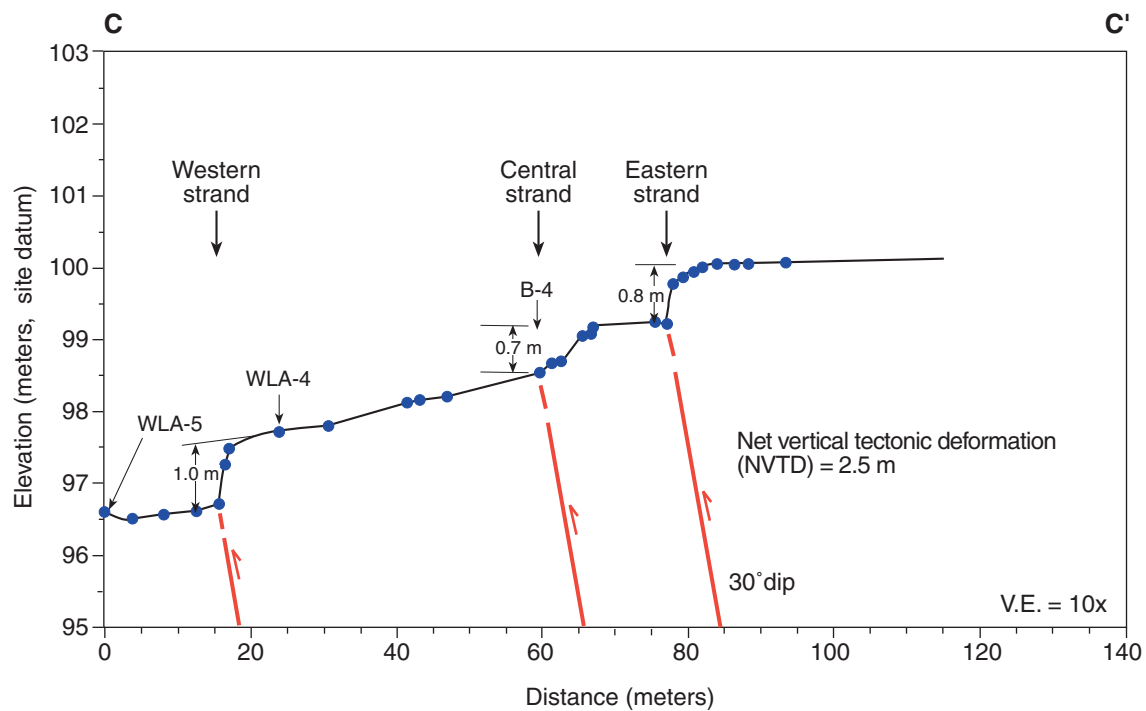
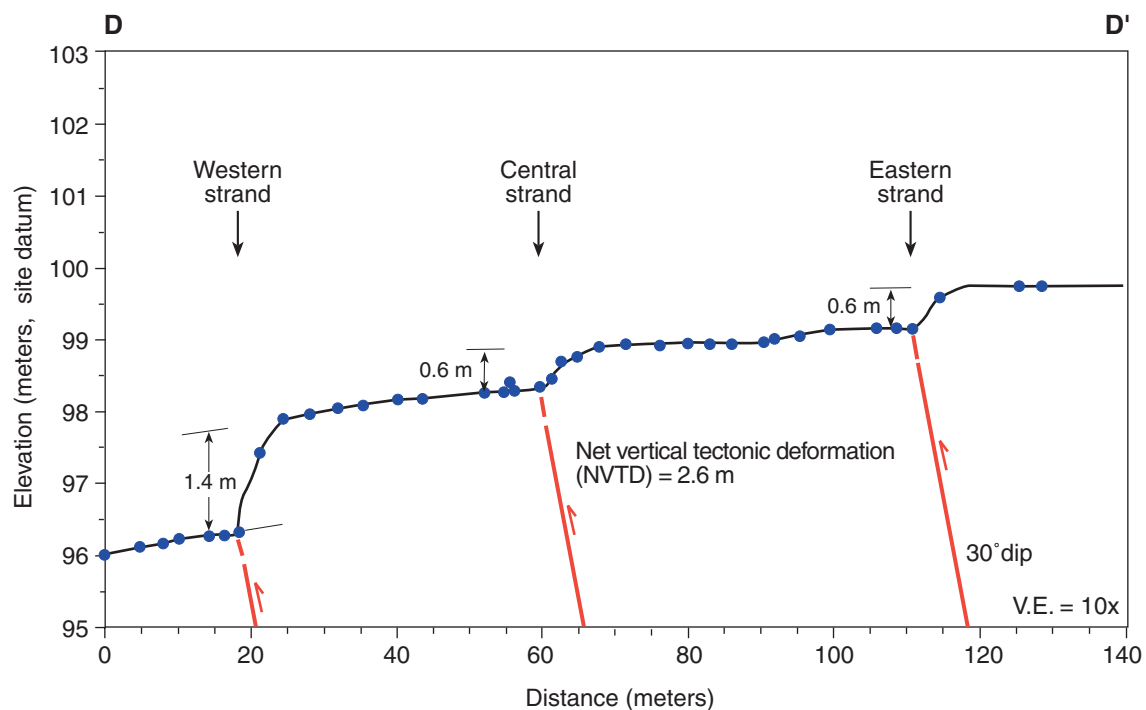
The central fault strand extends along the western side of the Eastern Classroom Building, branches northwestward into the campus quadrangle with a strike of about N25°W, and extends to the asphalt roadway north of campus. Topographic profiles across the central fault strand show a NVTD of about 0.6 to 0.7 m (Figures 7b and 8). A northward decrease in the NVTD along this strand is indicated by our previous measurement of only 0.3 m of NVTD along the asphalt roadway (Kelson et al., 2001a). North of the roadway, we were unable to map the central fault strand because of disturbances related to demolition of a one-story residential building that was damaged during the earthquake (Kelson et al., 2001b). We speculate that this strand may merge with the western fault strand to the north of our study area, or that the strain is transferred to this strand through distributed deformation of the hanging wall.

Figure 8. Topographic profiles CC' and DD', Kuangfu Middle School. Fault dip of 30°E is assumed. See Figure 6 for profile locations.

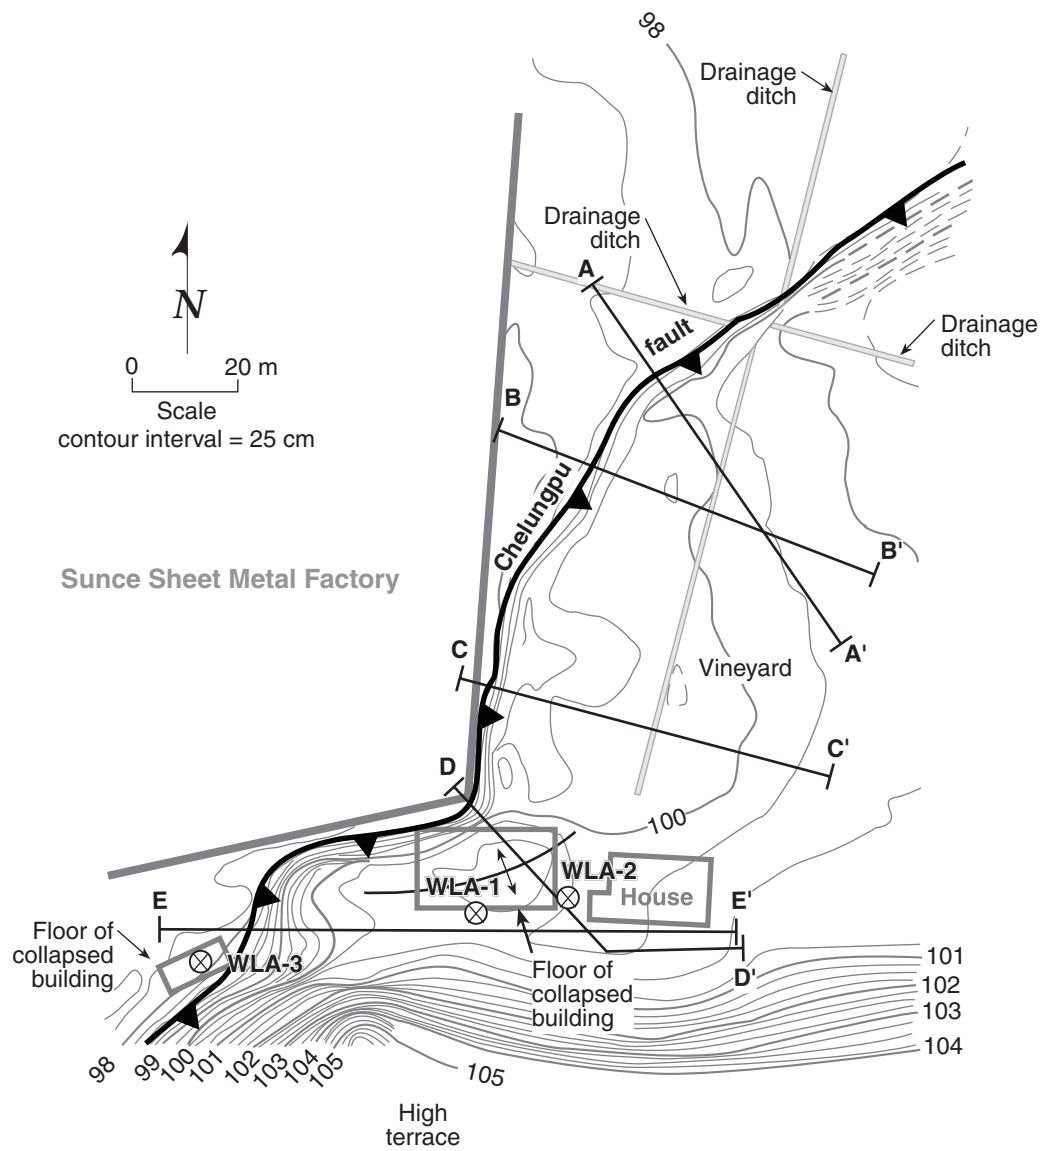
Figure 12. Topographic map of the Experimental Vineyard site, showing Chelungpu fault scarp, topographic profile locations, existing buildings, and boreholes (WLA-1, WLA-2, and WLA-3) completed in this study. Modified from Kelson et al. (2001b).

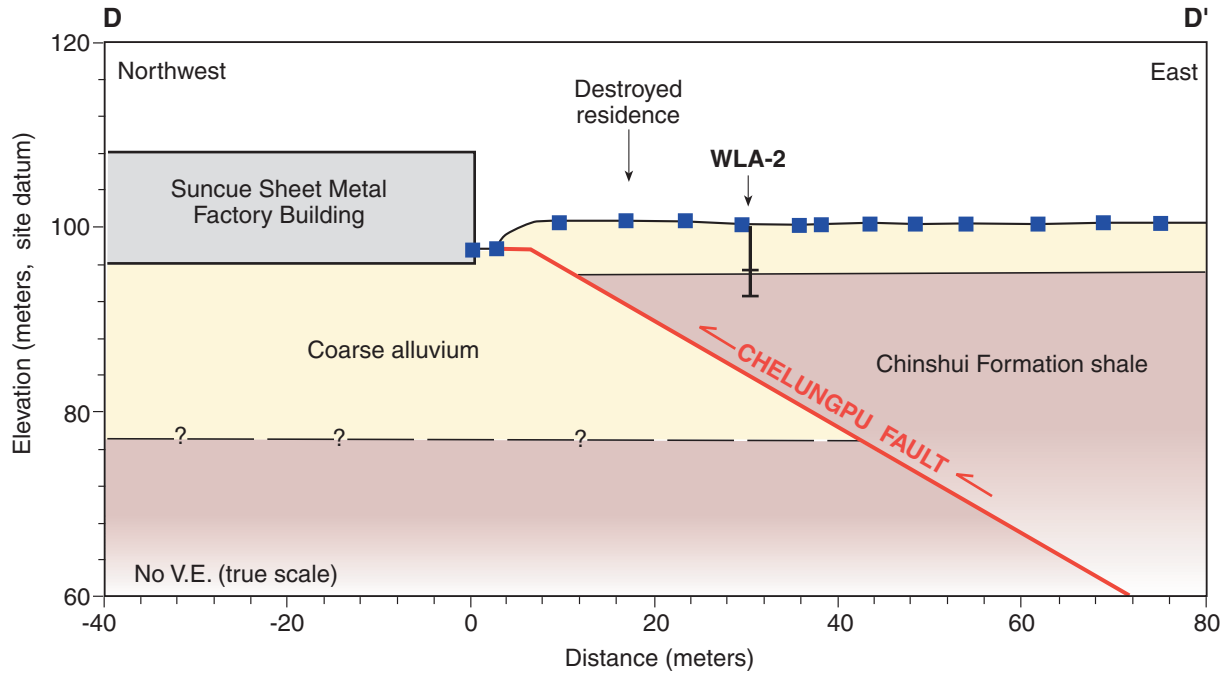
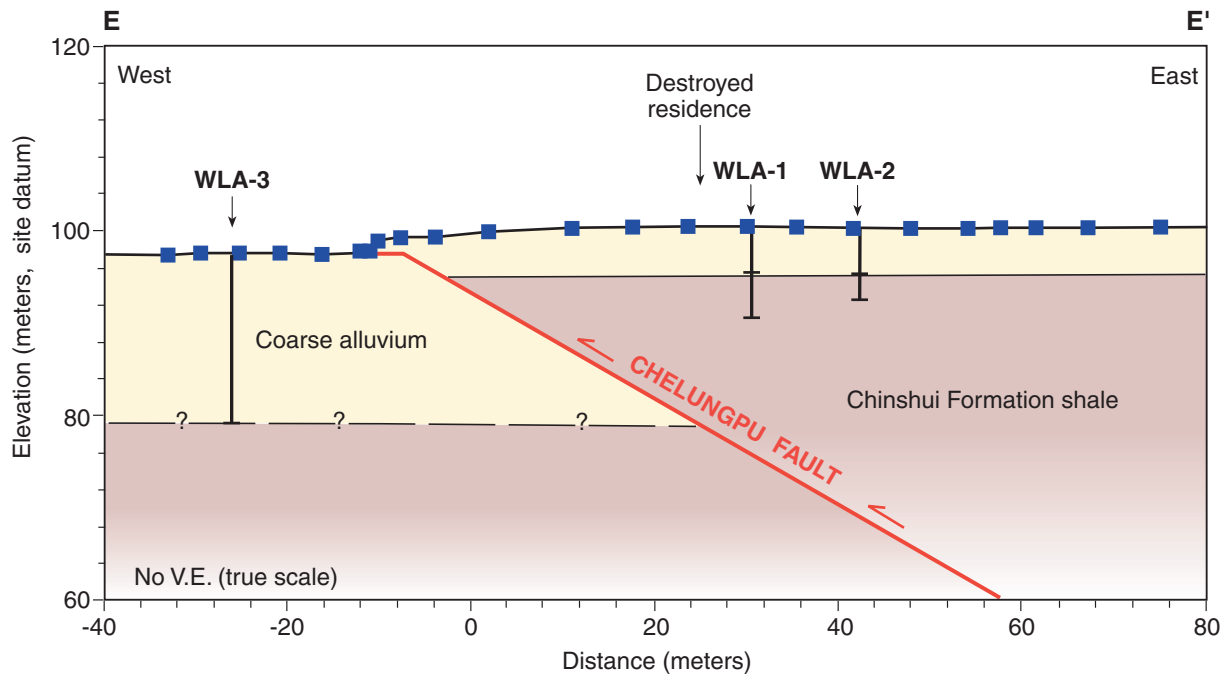
Figure 13. Topographic profiles DD' and EE' at the Experimental Vineyard site, showing shallow geologic conditions based on boreholes WLA-1 through WLA-3. See Figure 12 for locations.

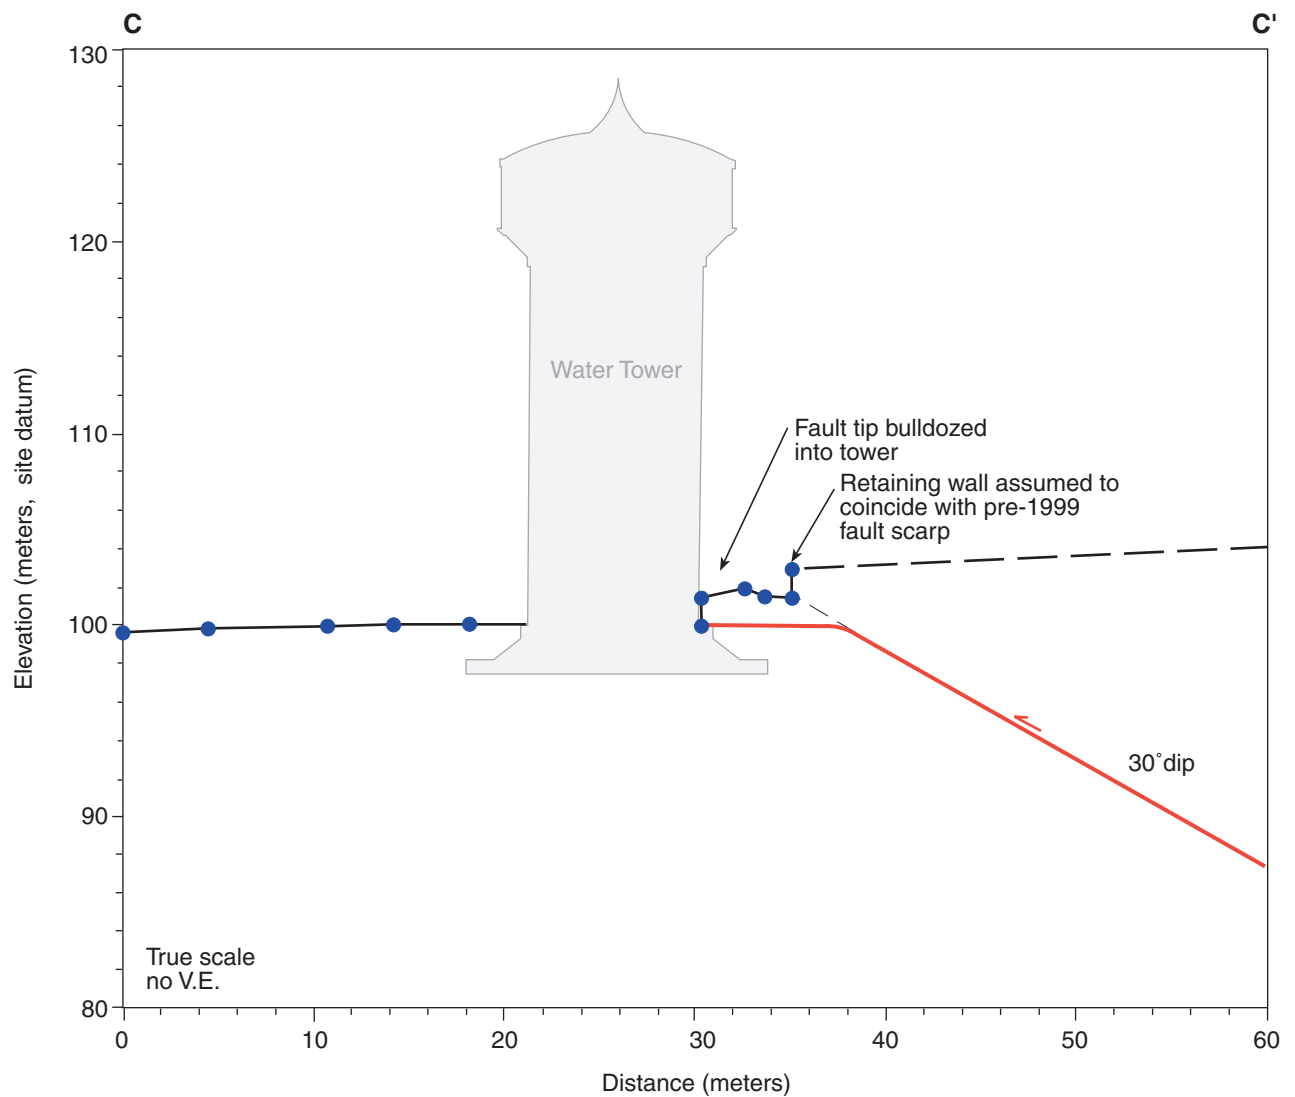
apparently affected the distribution and style of surface deformation. However, the tower was not damaged during the earthquake, and remains vertical despite the deflection of the fault scarp around its base. In contrast, circular pier foundations of the Highway 3 Bridge over the Wu Hsi were severely damaged by the surface rupture where it passes through the bridge structure. The damage to the piers, which have 16-m-deep caisson foundations, was much greater than that to the water tower, which has a foundation only 2.5 m deep. The difference in structural damage between these two sites illustrates the importance of siting structures on the footwall rather than across the fault trace. In conclusion, these sites show that the location, orientation, and type of buildings may influence patterns of shallow deformation (and damage to adjacent buildings).

Figure 16. True-scale topographic profile CC' at the Tsaotun Water Tower site, showing tower structure and foundation based on as-built plans, and inferred location of the Chelungpu fault (assumed 30° dip). See Figure 15 for location of CC'.

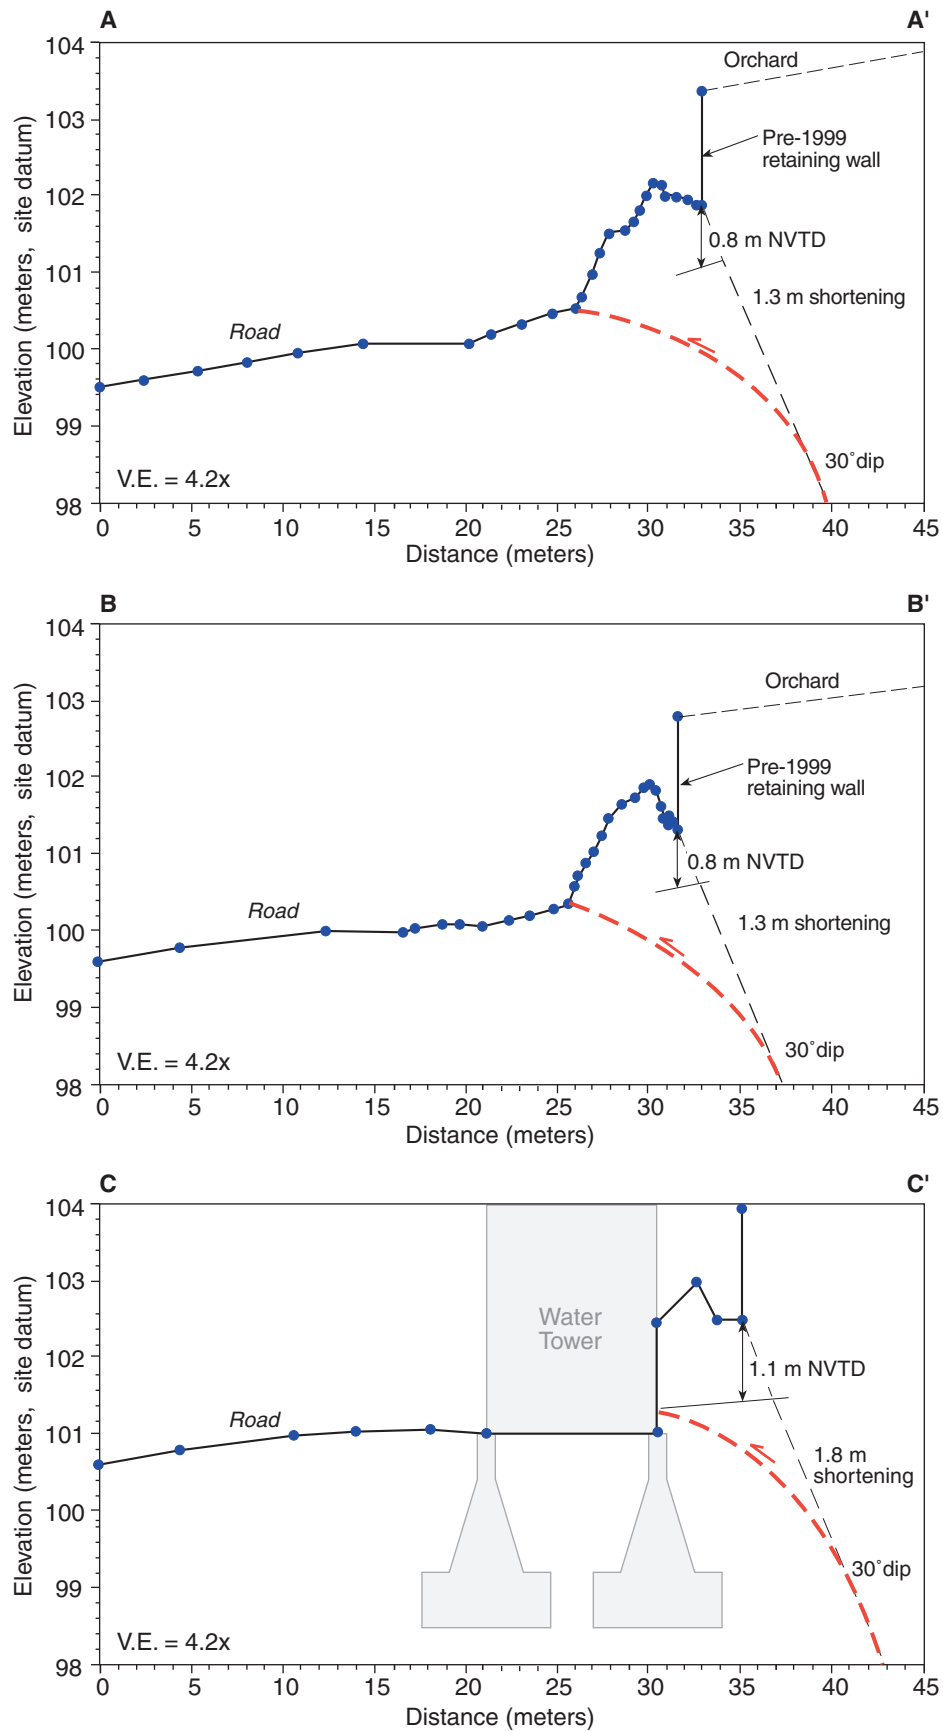
Figure 18. Topographic profiles AA' through CC', Tsaotun Water Tower site. Fault dip of 30° is assumed. See Figure 15 for profile locations.

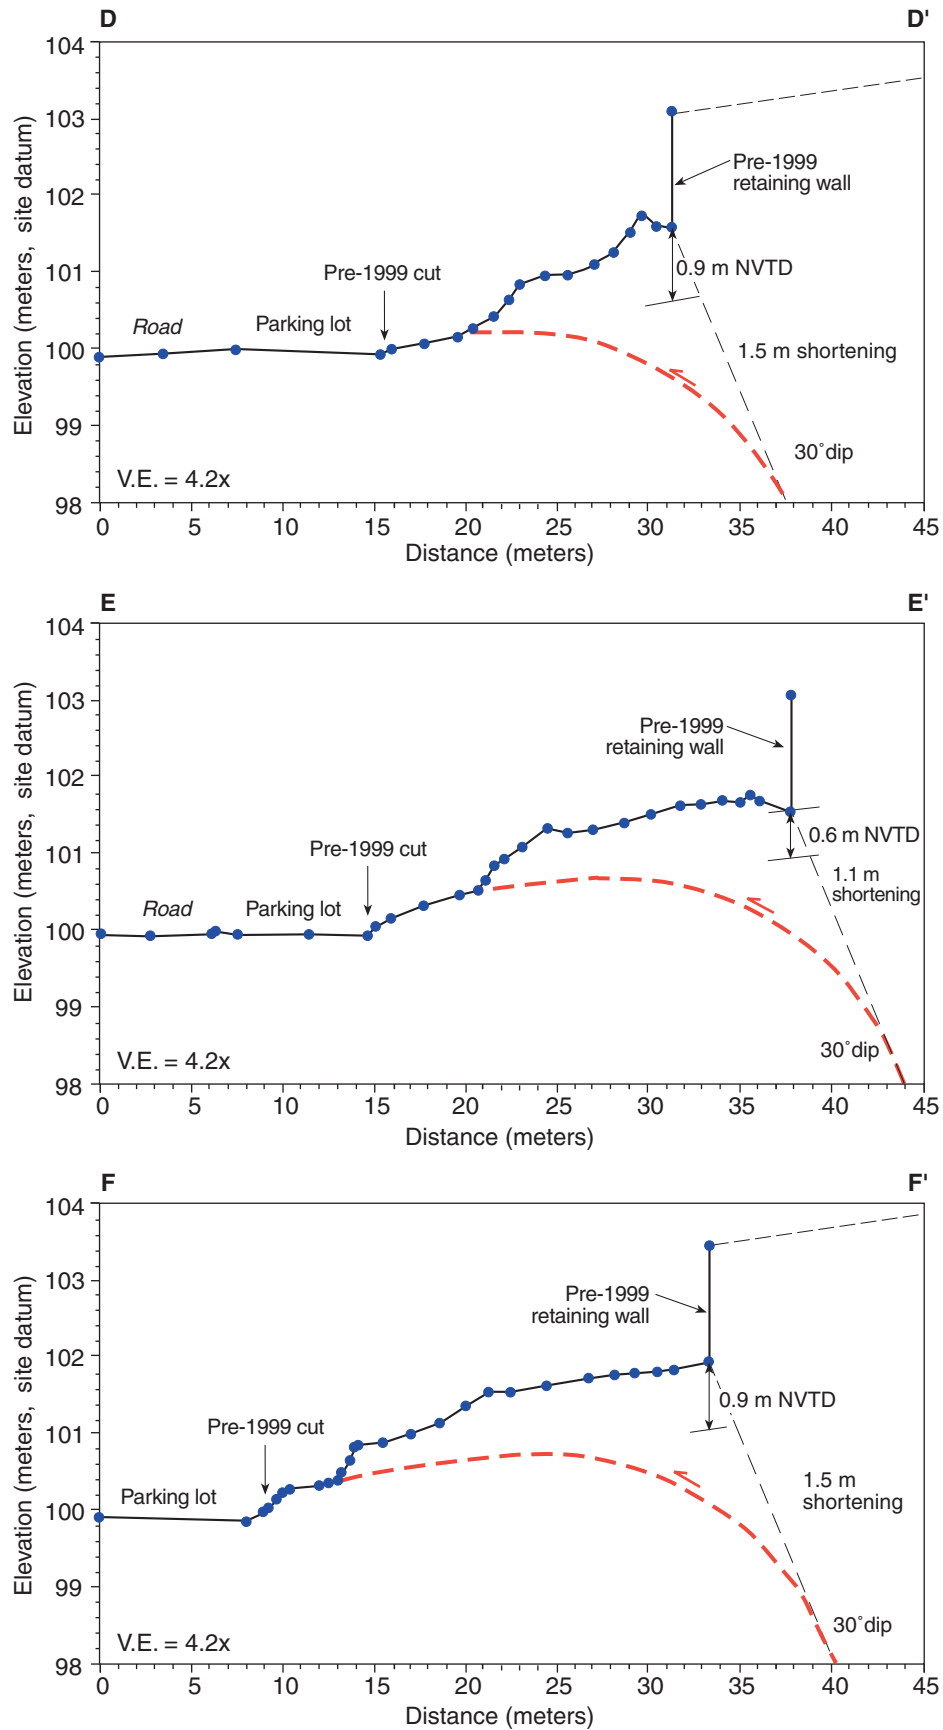
Figure 19. Topographic profiles DD' through FF'. Fault dip of 30° is assumed. See Figure 15 for profile locations.

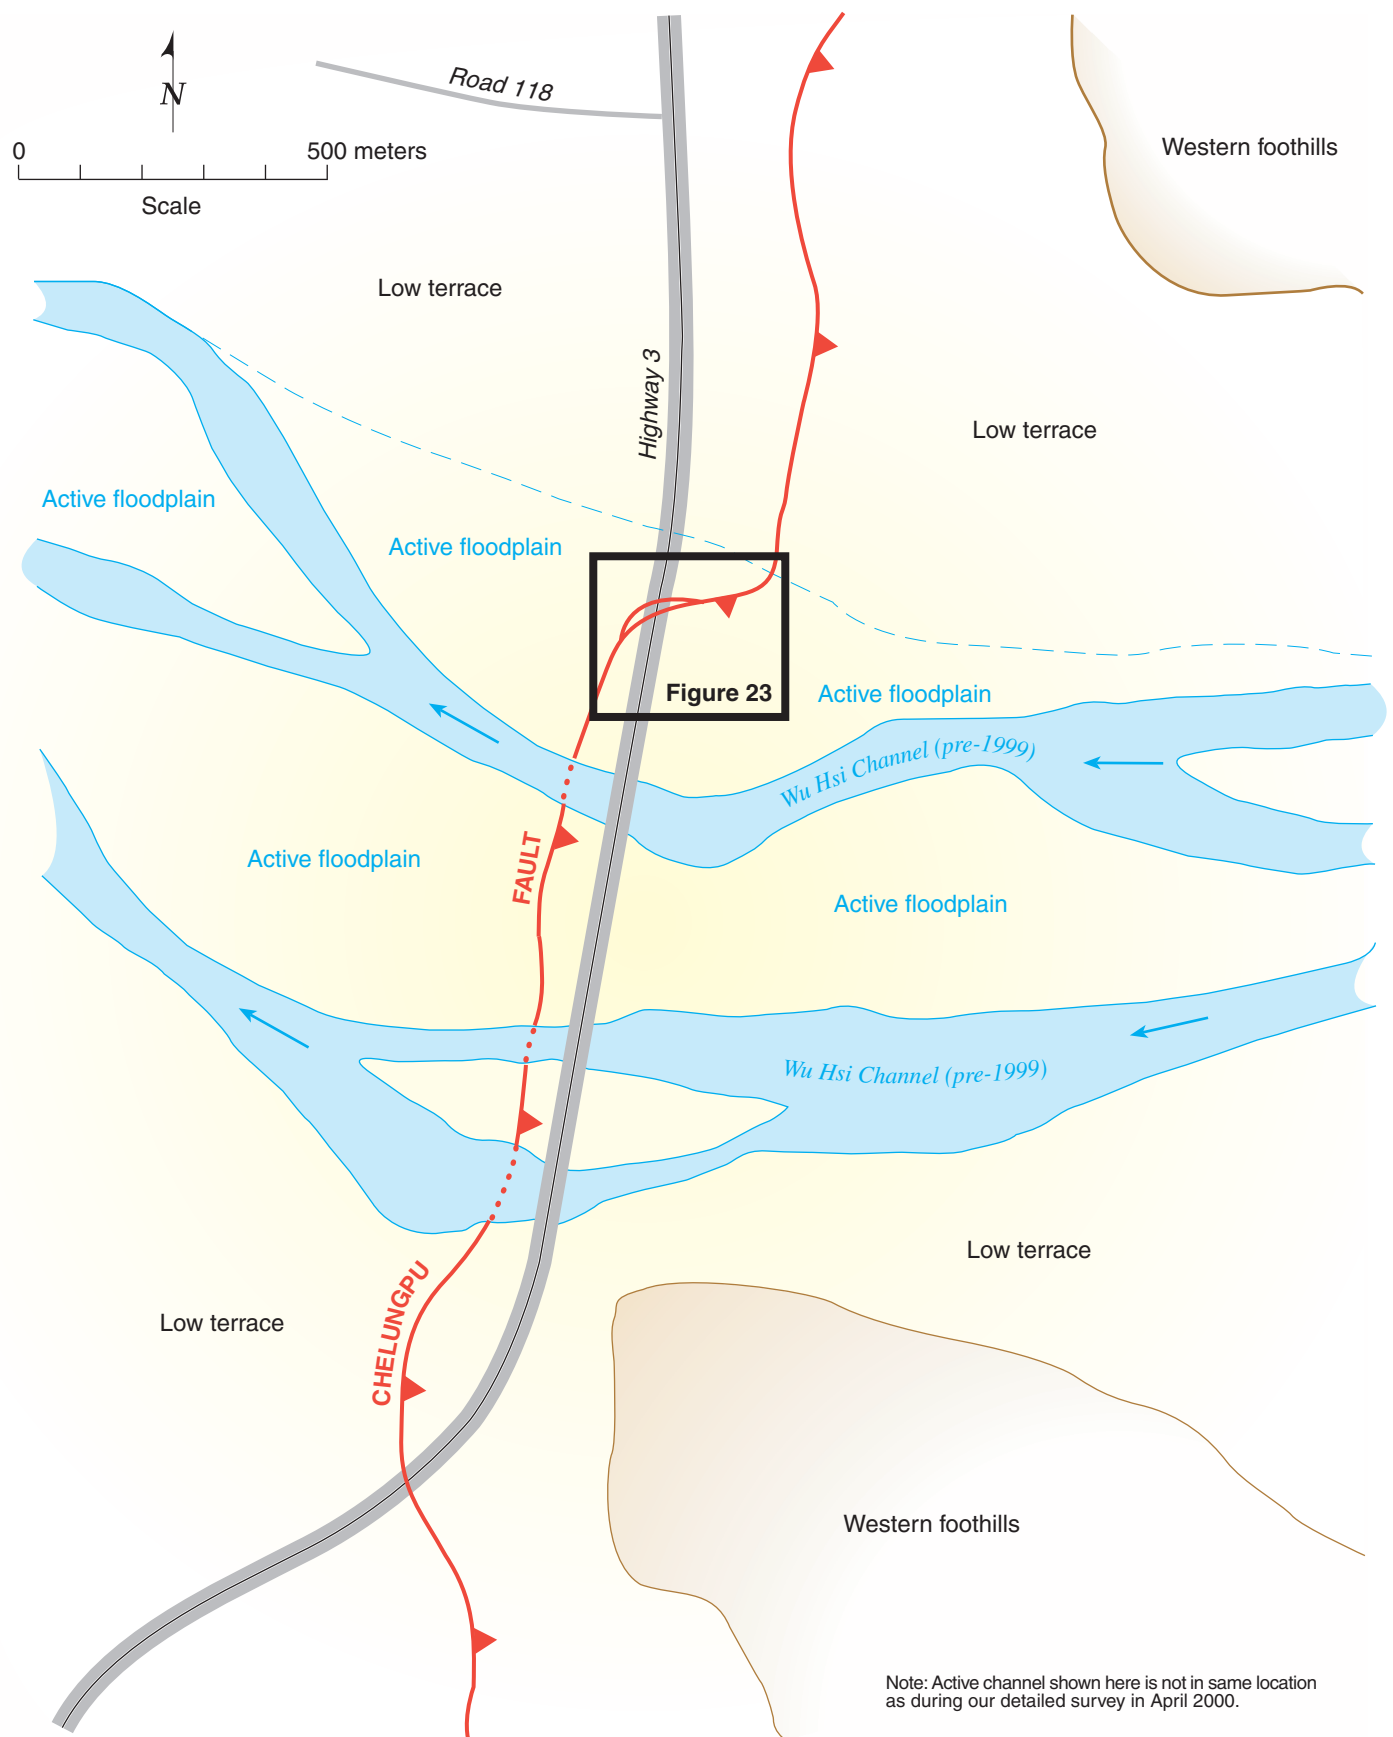
Figure 21. Generalized geologic map of the Chelungpu fault in the vicinity of the Wu Hsi Bridge. The trace of the 1999 surface rupture is modified from mapping by the Taiwan Central Geological Survey.

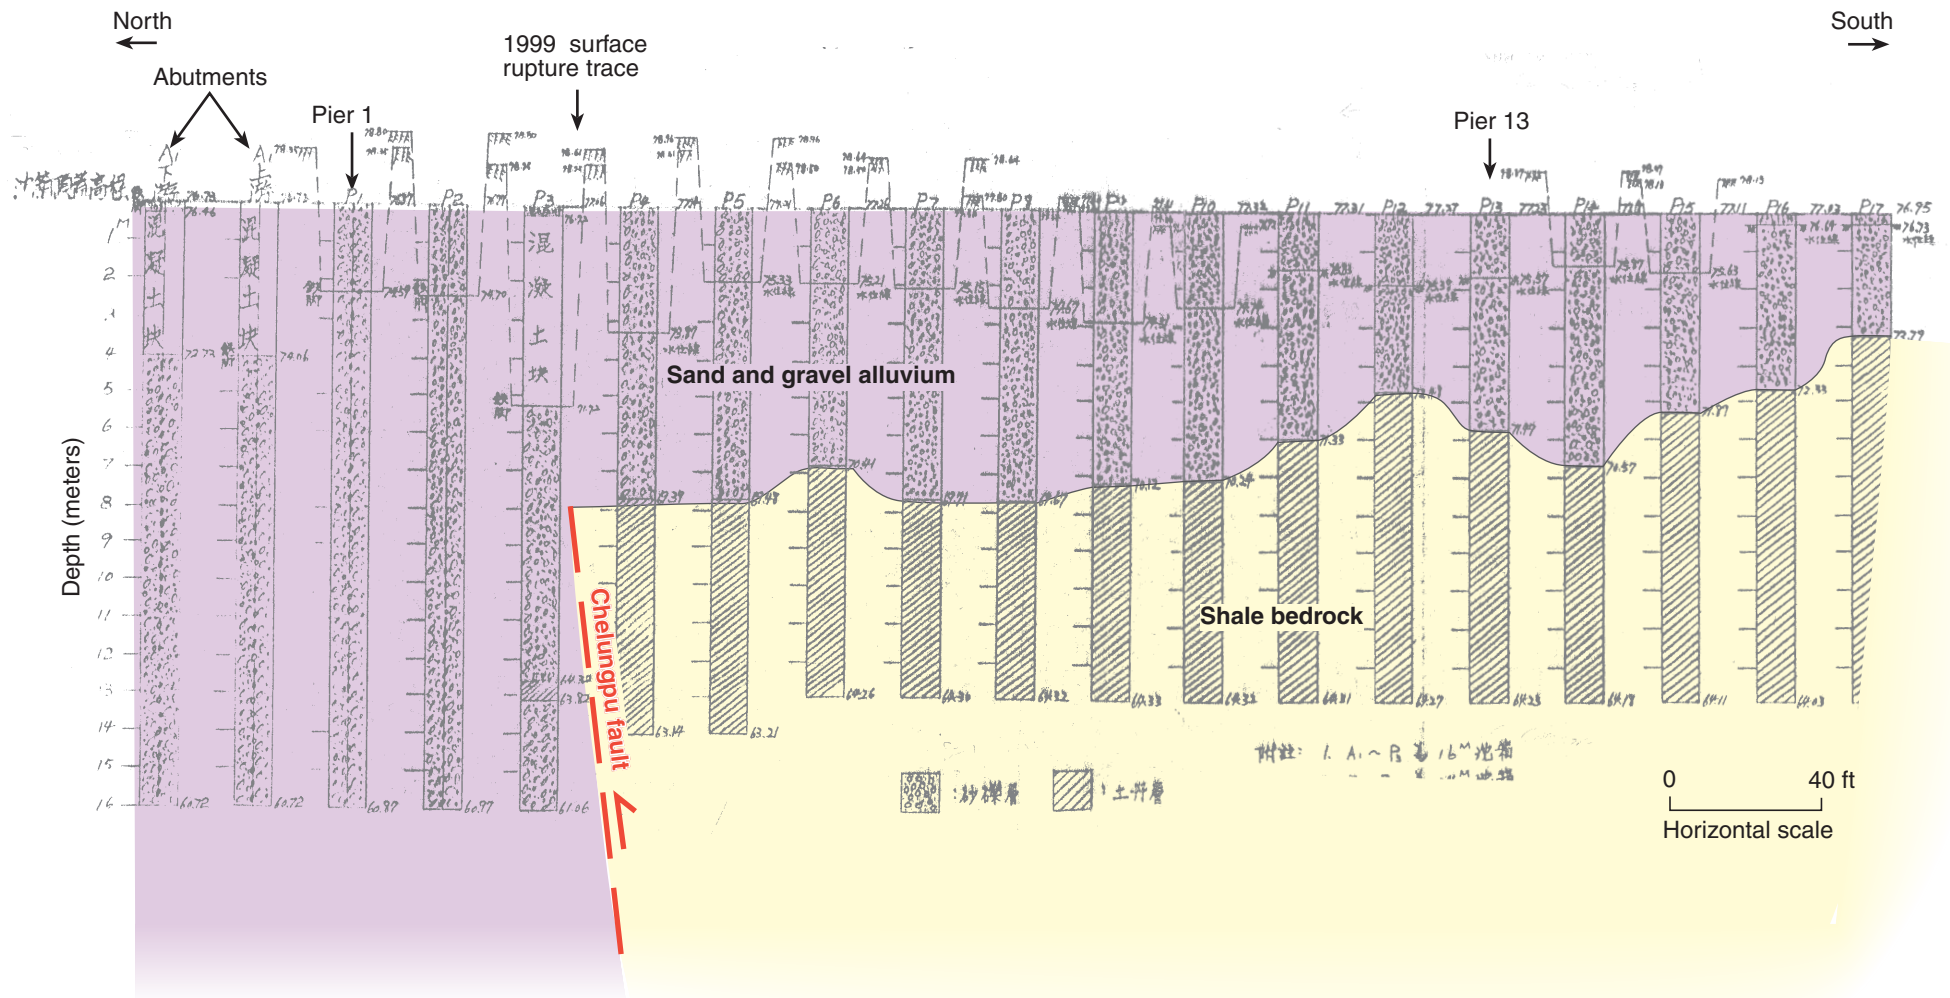
Figure 22. Geologic cross section at Wu Hsi Bridge prior to the 1999 Chi-Chi earthquake, based on logs of excavations for pier caissons.

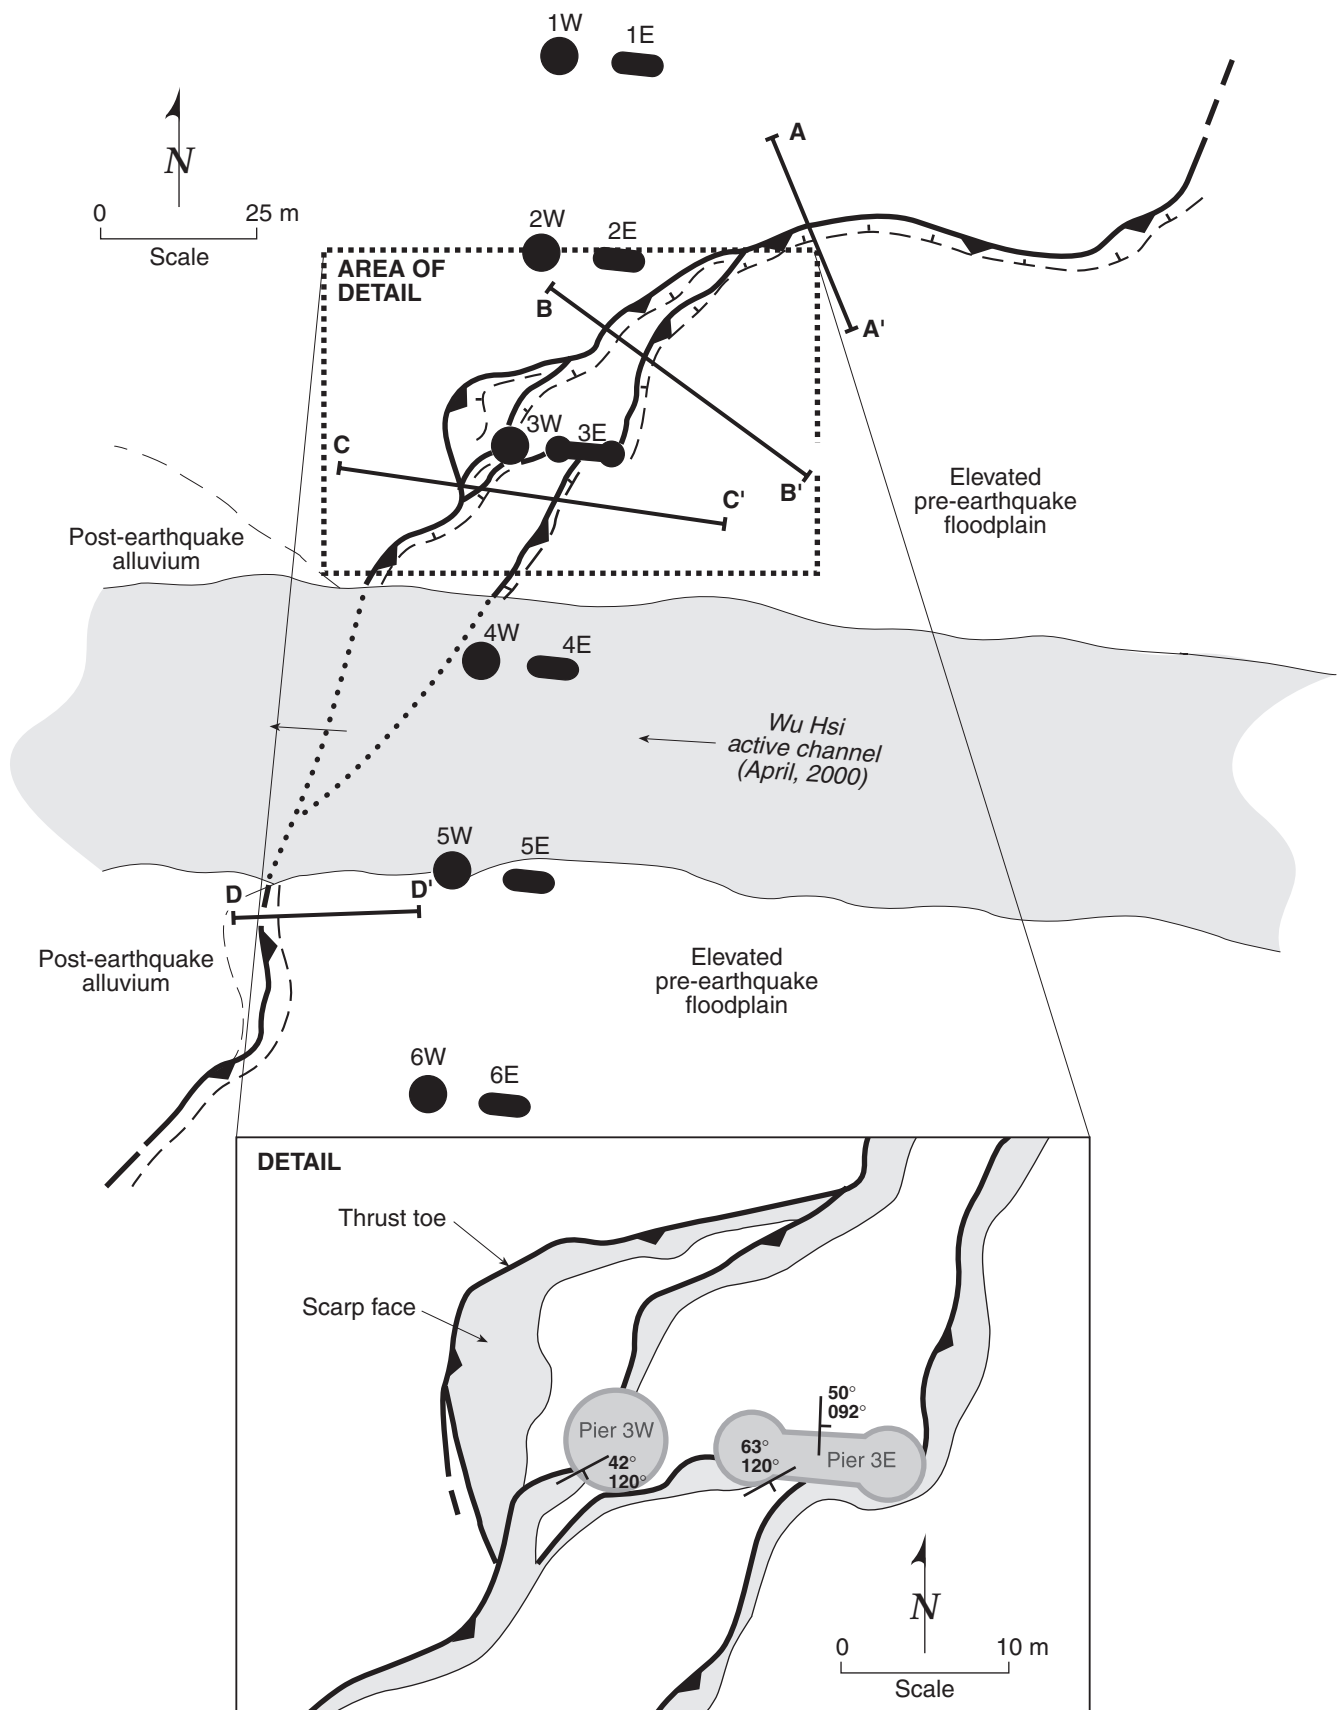
Figure 23. Detailed map of the 1999 Chelungpu fault rupture through the Wu Hsi Bridge, showing locations of bridge piers, fault strands, and topographic profiles. Inset map shows details of fault rupture near Piers 3w and 3E, and orientations of fractures developed in the piers.
